NATIONAL PROGRAM FOR INSPECTION OF NON-FEDERAL DAMS
PACKERS FALLS DAM (NH.) (U) CORPS OF ENGINEERS WALTHAM
MA NEW ENGLAND DIV DEC 80

PACKERS FALLS DAM

NH 00441

PHASE I INSPECTION REPORT
NATIONAL DAM INSPECTION PROGRAM

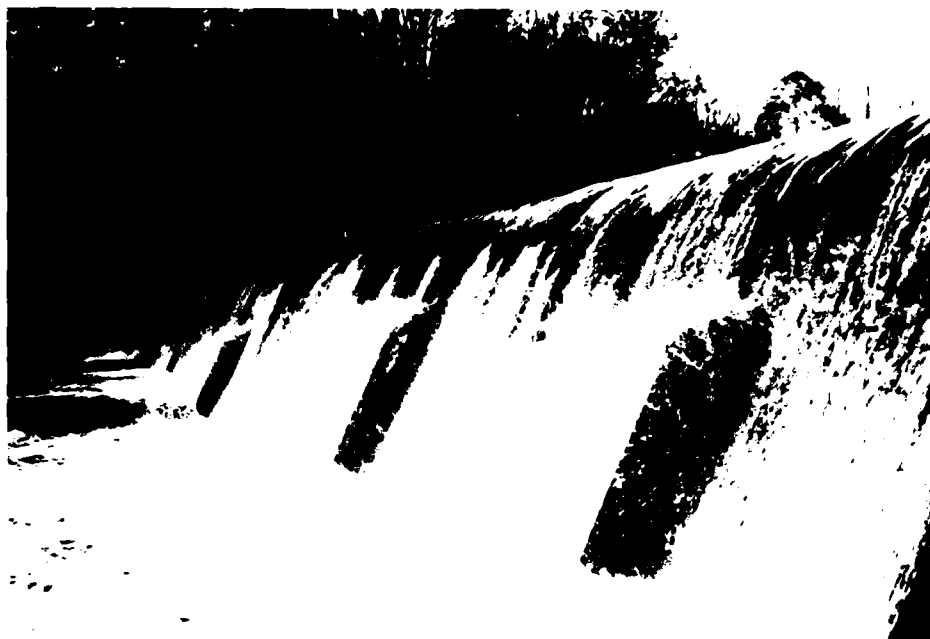
The spillway was inspected under high flow conditions. It is a concrete structure founded on bedrock which was repaired with an application of pneumatic mortar. There are two continuous horizontal construction joints in the mortar application which have been subjected to spalling. These horizontal joints are located approximately 1 foot and 10 feet below the crest of the spillway. A considerable amount of pneumatic mortar has been eroded from the downstream face of the spillway. The deterioration can be attributed to ice damage.

1. Principal Spillway - Note Buttresses on Downstream Face.

(c) Inspect the spillway under low flow conditions and evaluate the effect on the structural stability if flashboards were used.
